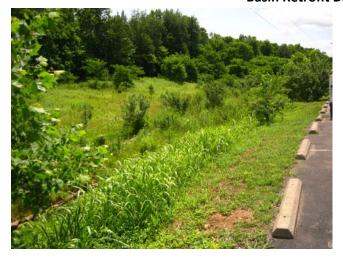
<u>Basin ID #:</u> WR+14+E3 <u>Property Owner:</u> Enterprise Office & Warehouse, LLC

<u>Additional Comments:</u> No issues observed during inspection. It appears there is a wetland area and pond located in the northeastern portion of the basin.

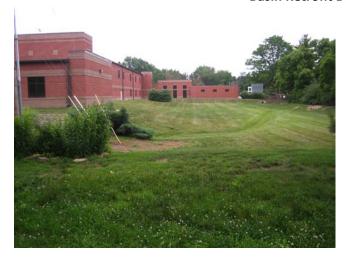
Basin ID #: WR+39+E6

<u>Additional Comments:</u> No issues observed during inspection.
