Hydrogeomorphic Assessment Report

Wolf Run Watershed Fayette County, Kentucky

September 4, 2012

Prepared by
Third Rock Consultants, LLC
2526 Regency Road, Suite 180
Lexington, KY 40503
859.977.2000

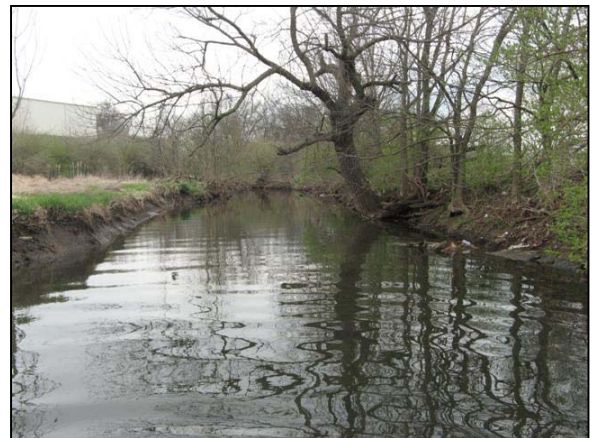
*W1, 2011, Left Bank Erosion Area within
Surveyed Reach*

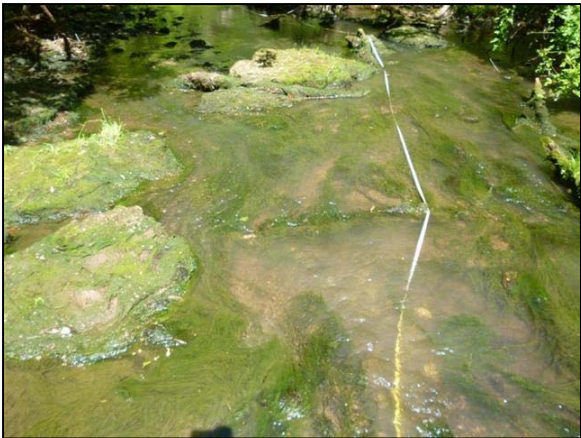
*W1, 2012, Section Where Bank Stabilization And
Riparian Enhancement Would Be Beneficial*

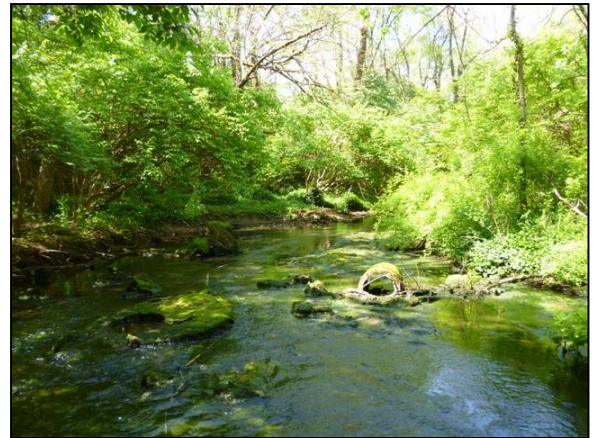
*W2, 2012, Significant Amounts of Algae Observed
throughout Surveyed Reach*

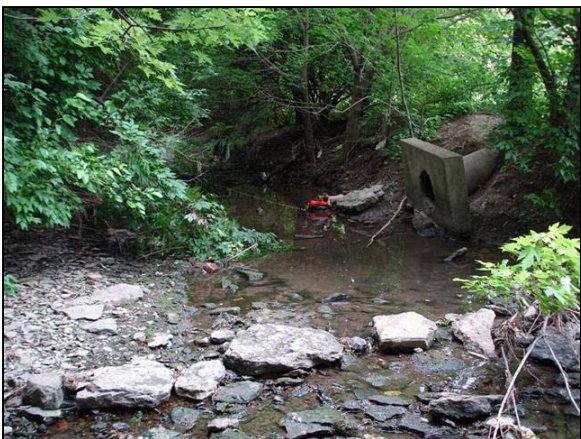
*W2, 2012, Riparian Canopy, But Contains A
Significant Invasive Species; Algae And
Sedimentation Reduce Aquatic Habitat*

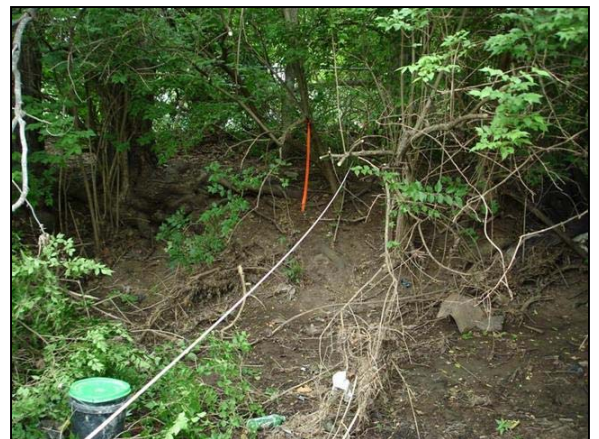
*W4, 2011, Erosion Around Stormwater
Infrastructure*

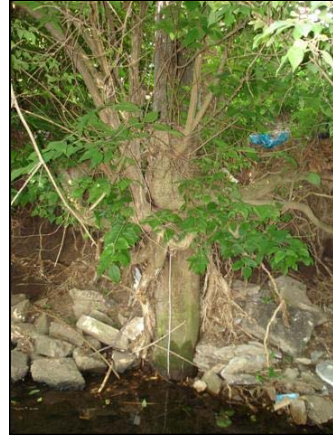
W4, 2012, Left Bank Erosion within Surveyed Reach; Exposed Tree Roots

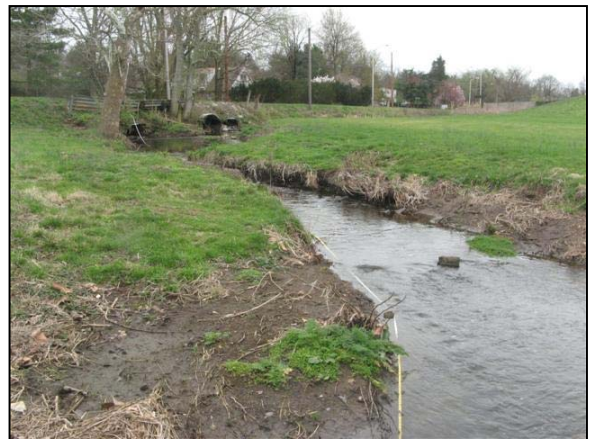
W5A, 2011, Wetland And Lawn Areas Adjacent To Surveyed Reach

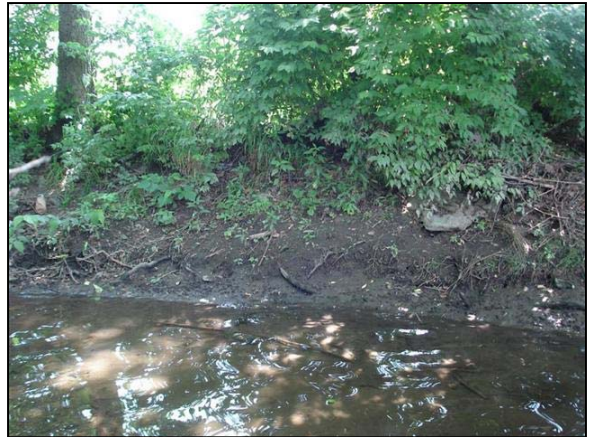
W6, 2011, Embedded Substrate; Little Vertical Streambed Diversity

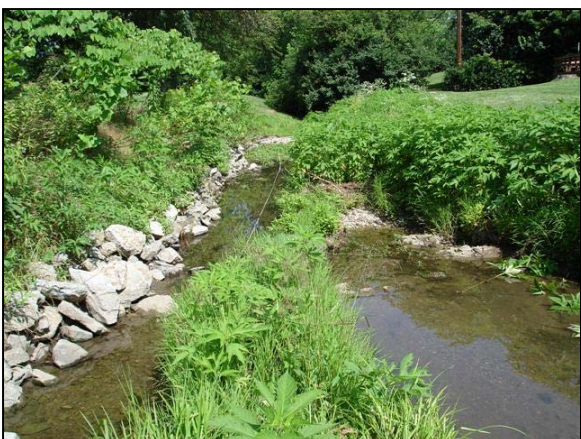
W7, 2011, Exposed Infrastructure

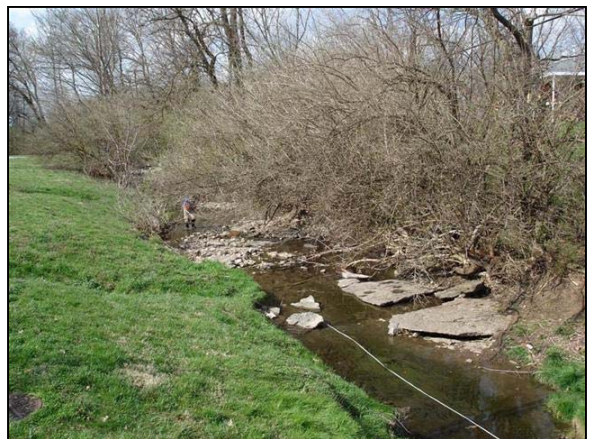
W7, 2011, Instream Deposition within Degraded Stream Channel

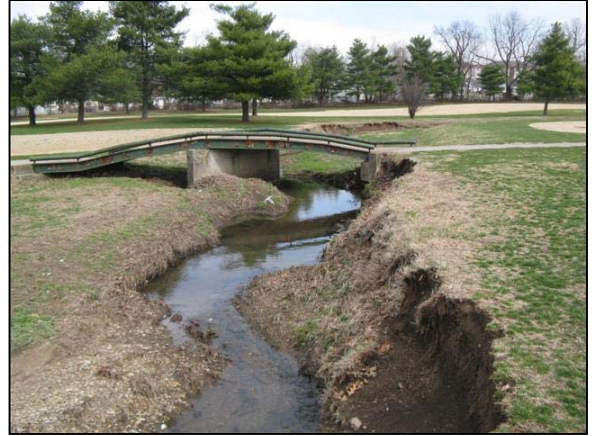
W8, 2011, Bank Erosion and No Riparian Buffer

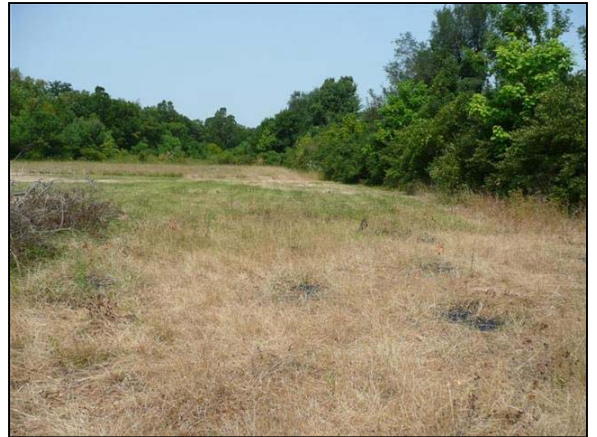
*W9, 2011, Poor Quality Riparian Zone Offering Little
Bank Protection*

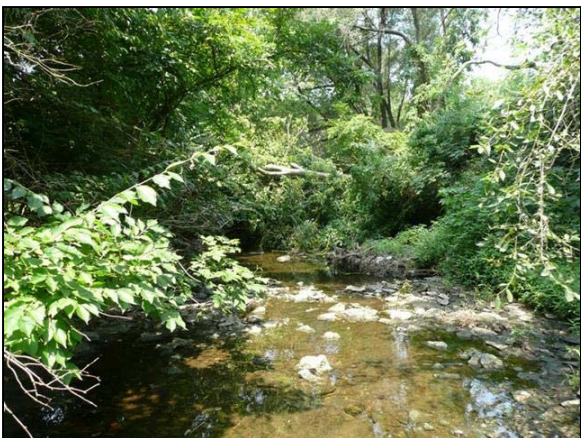
*W9, 2012, Available Area Along Left Bank for
Additional Riparian Zone Expansion*

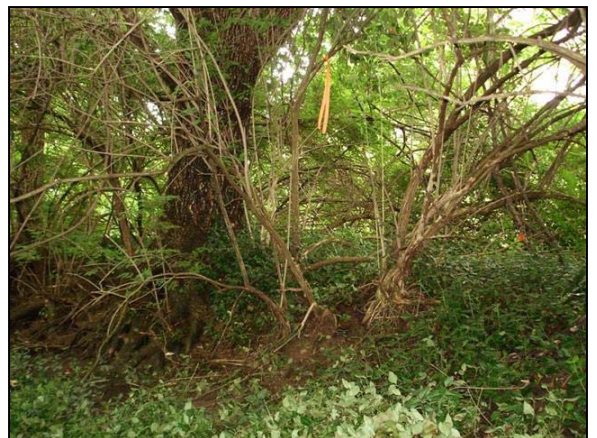
*W9, 2012, Downed Tree Across Stream May Lead
to Additional Channel Degradation*

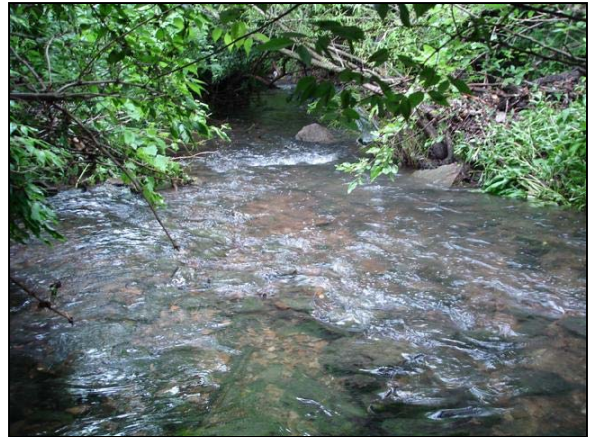
W11, 2011, Concrete Armoring Within Surveyed Reach
