# Karst Hydrograph Characterization Report

## Wolf Run Watershed Fayette County, Kentucky

June 28, 2012

*Prepared by*  
Third Rock Consultants, LLC  
2526 Regency Road, Suite 180  
Lexington, KY 40503  
859.977.2000

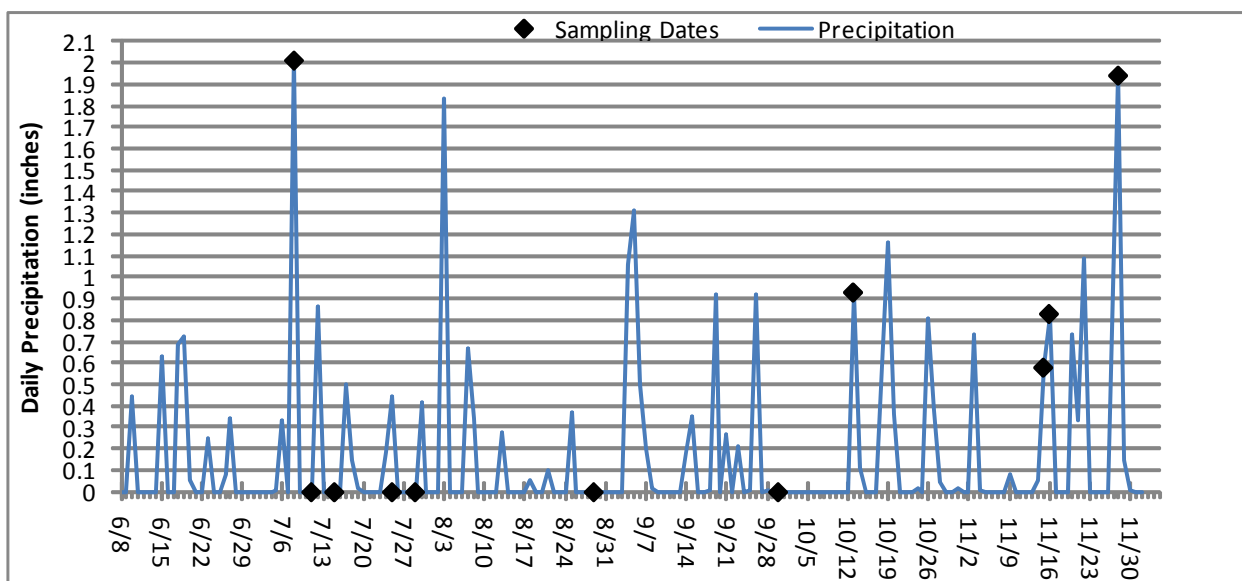
**FIGURE 2 – PRECIPITATION DURING MONITORING PERIOD**

NOTE: Precipitation values based on KLEX weather station data from <http://www.wunderground.com>.

Stream flow measurements were performed on 11 days as shown in Table 2. Six monitoring events were conducted during base flow while five events measured stream flow during precipitation. Two events were conducted during storms where more than 1" of daily rainfall was recorded at the Bluegrass airport. The monitoring dates in relation to the daily precipitation are shown in Figure 2. Precipitation was recorded on 62 of the 185 days in which the data loggers were deployed, or 34% of the days in the monitoring period. Of the 62 days in which precipitation was recorded, only 8 had over 1" of rainfall.

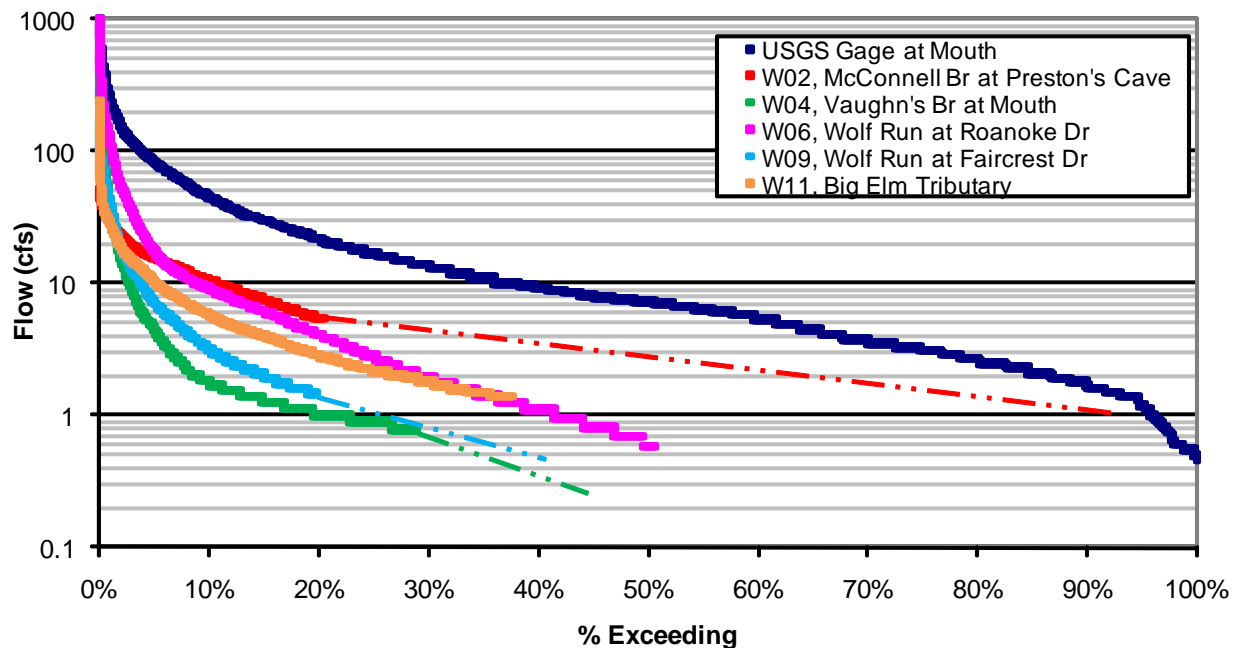
FIGURE 8 – RELATIONSHIP BETWEEN FLOWS OVER THE MONITORING PERIOD

NOTE: Dotted lines indicate inferences beyond the valid data logger data based on field measurements.

Table 7 and Figure 8 summarize the stream flow data in a flow duration curve, which indicates the percentage of time a given flow was exceeded for the monitoring period. These results indicate the flashiness of streams throughout the watershed and the range of flow values that

occur at the sites. The maximum flows calculated at each site are 1150 cfs at the USGS gage at the mouth of the watershed, 51 cfs at McConnell Branch at Preston's Cave, 668 cfs at the mouth of Vaughn's Branch, 1157 cfs at Wolf Run at Roanoke Drive, 170 cfs at Wolf Run at Faircrest Drive, and 238 cfs at the Big Elm Tributary. In Figure 8, the solid lines indicate the flows based on valid logger data; dotted lines are projections beyond the valid logger data based on field measured flow observations under dry weather conditions.

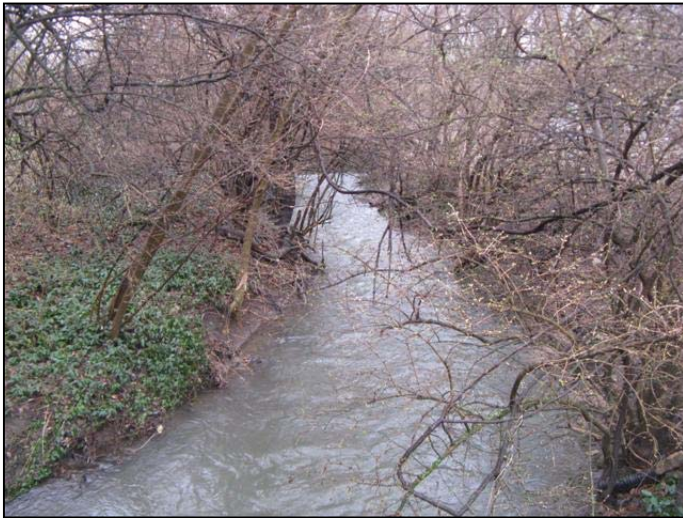
*Upstream view of Big Elm Tributary monitoring site during March 9, 2011 storm event.*

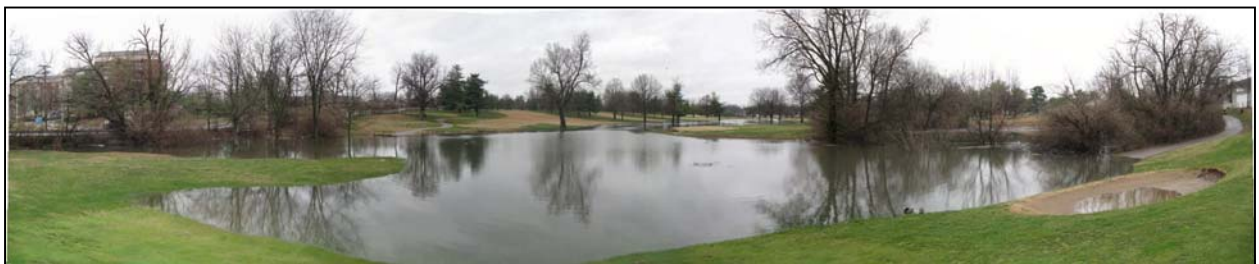
*Panoramic view of Picadome Sinkhole flooding during storm event on March 9, 2011. The sinkhole is located to the right with water traveling from the Big Elm tributary (left), across to Vaughn's Branch (distant center).*

During the November 15-16 and November 27-29 storm events, the Picadome sinkhole was monitored for surface flows across the golf course fairways into Vaughn's Branch. No surface flow was observed during the November 15-16 storm event, shown in Figure 10, in which flow levels reached a maximum of 32 cfs at the Big Elm Tributary site (W11). On November 28, however, surface flow was field measured twice at 10:55 AM and 1:10 PM, measuring 29.8 cfs and 29.5 cfs at the confluence of the Big Elm Tributary and Vaughn's Branch. These surface flow measurements correspond to data logger flow readings of 32 and 30 cfs, respectively, at the Big Elm Tributary. These measurements indicate that almost all flow is following the surface flow route into Vaughn's Branch under conditions when surface flow is present. McConnell Branch (W02) reached maximum levels of 46 cfs in response to these karst groundwater flows. This seems to indicate that when the karst conduit's flow capacity is

maximized, through upstream inputs such as Wolf Run at Southbend Drive or through the maximized capacity at the spring outlets, water begins to back up at the Picadome sinkhole until the flood levels are sufficient to allow for the

bypass across to Vaughn's Branch. Once the groundwater system has additional capacity to accept additional flow input, floodwaters begin to decline at the Picadome sinkhole.

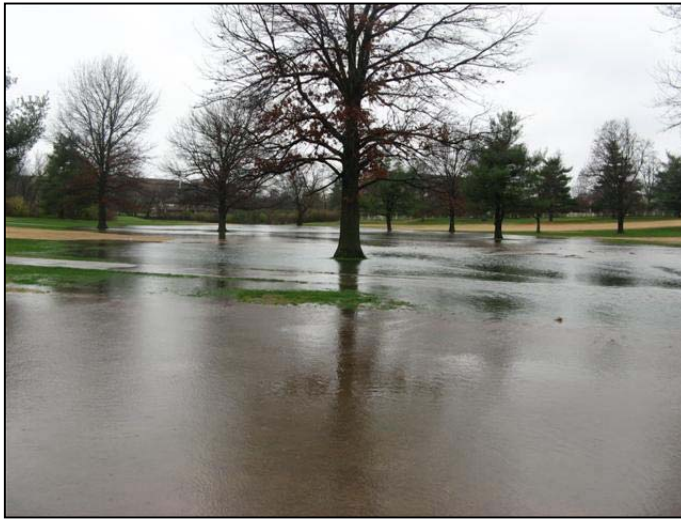
*Upstream view of flow path and erosion from Big Elm Tributary to Vaughn's Branch due to storm event on November 28, 2011*

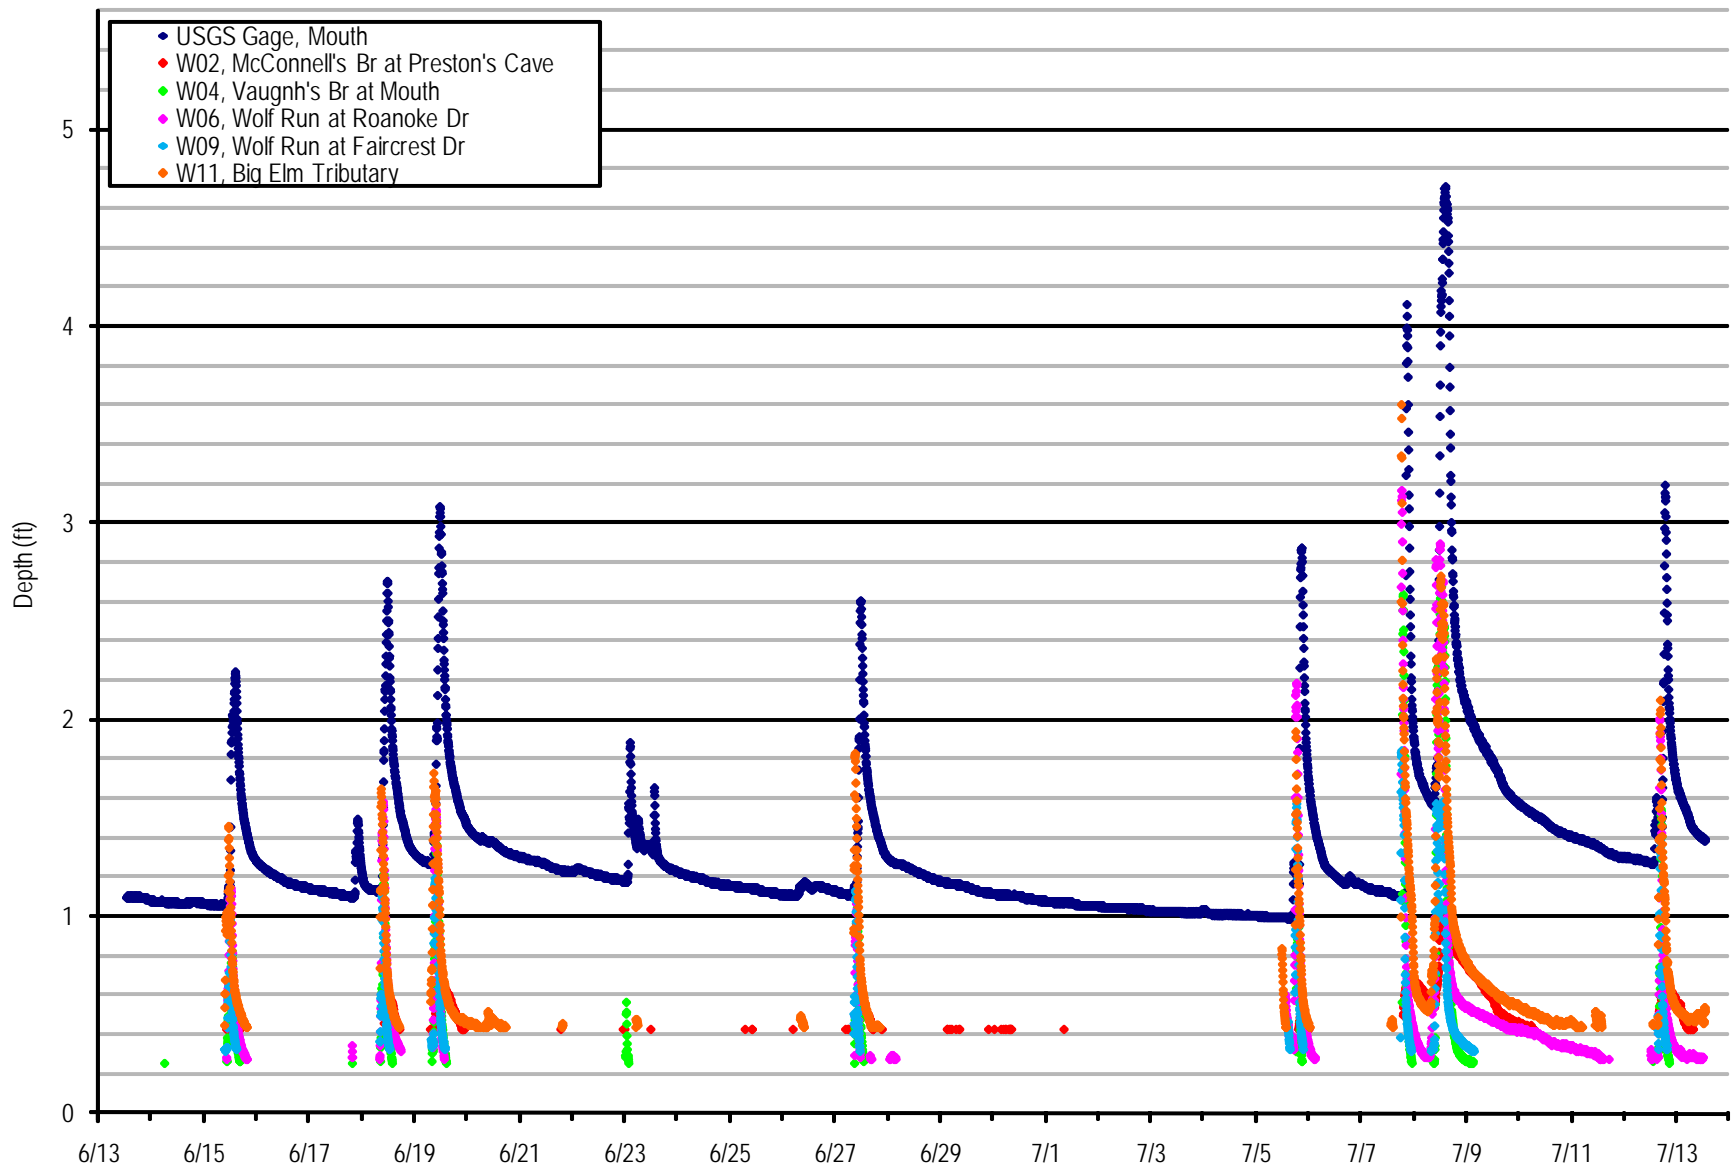
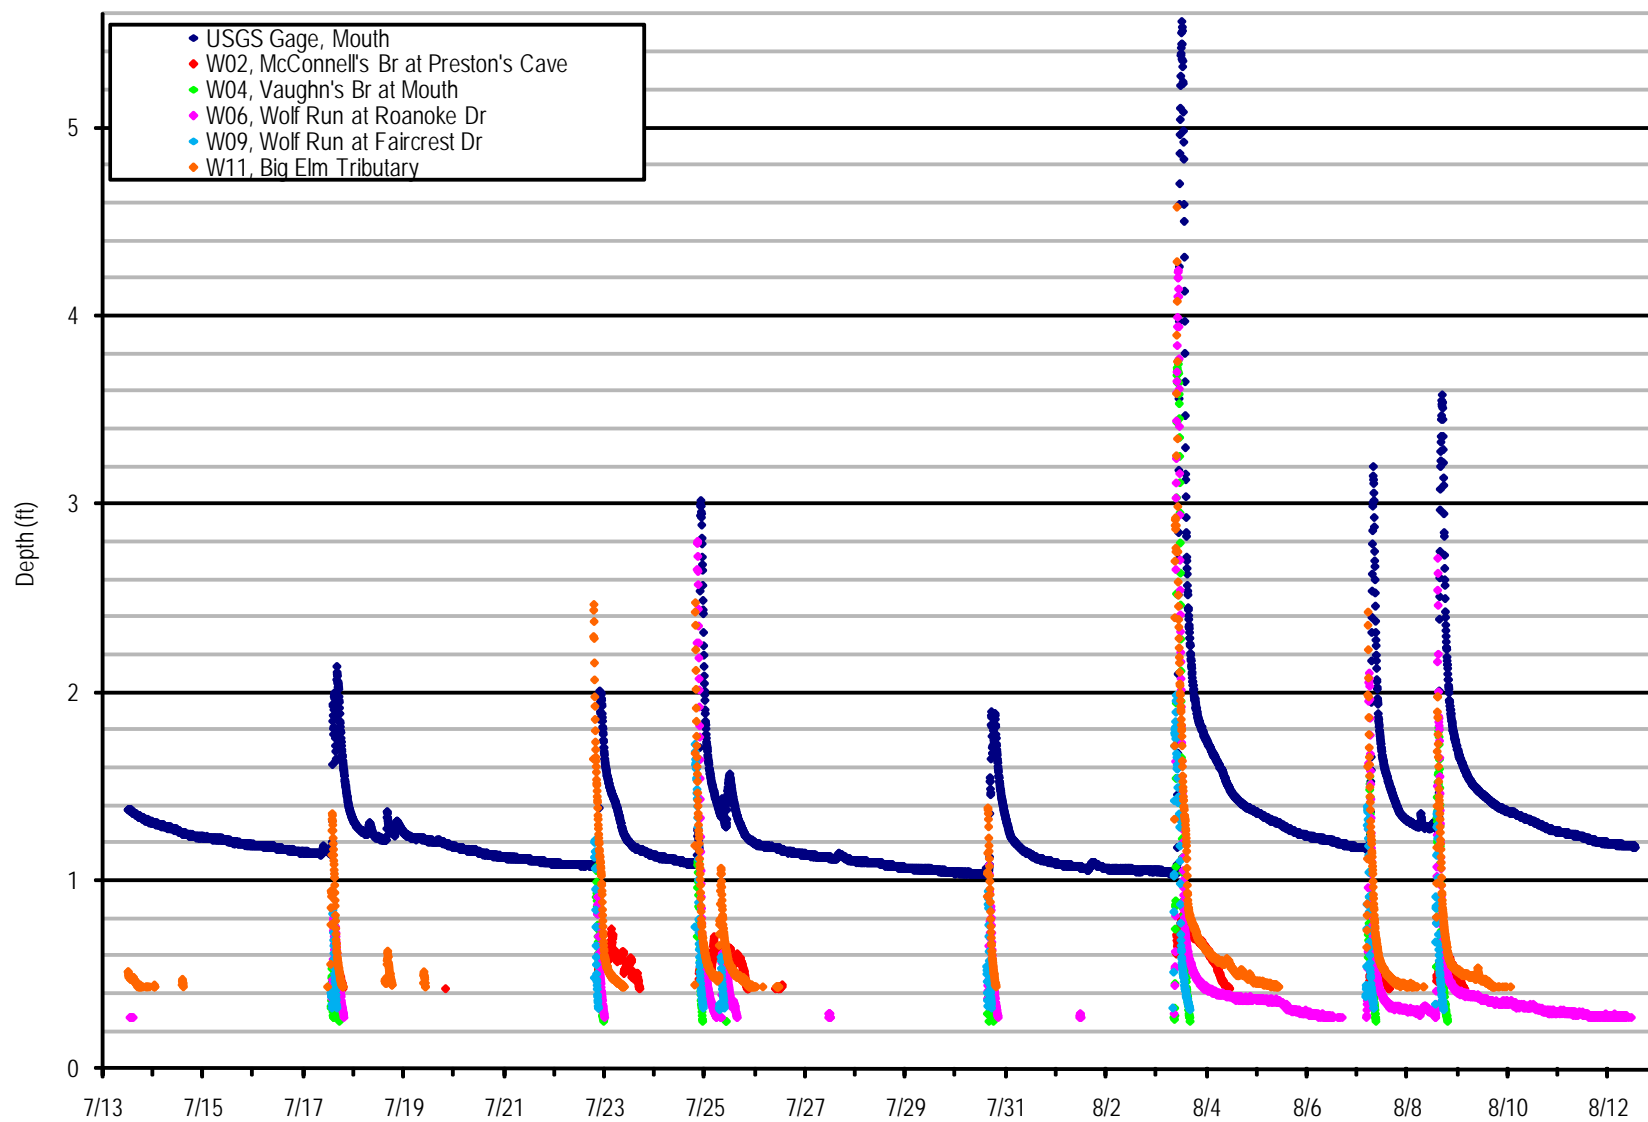
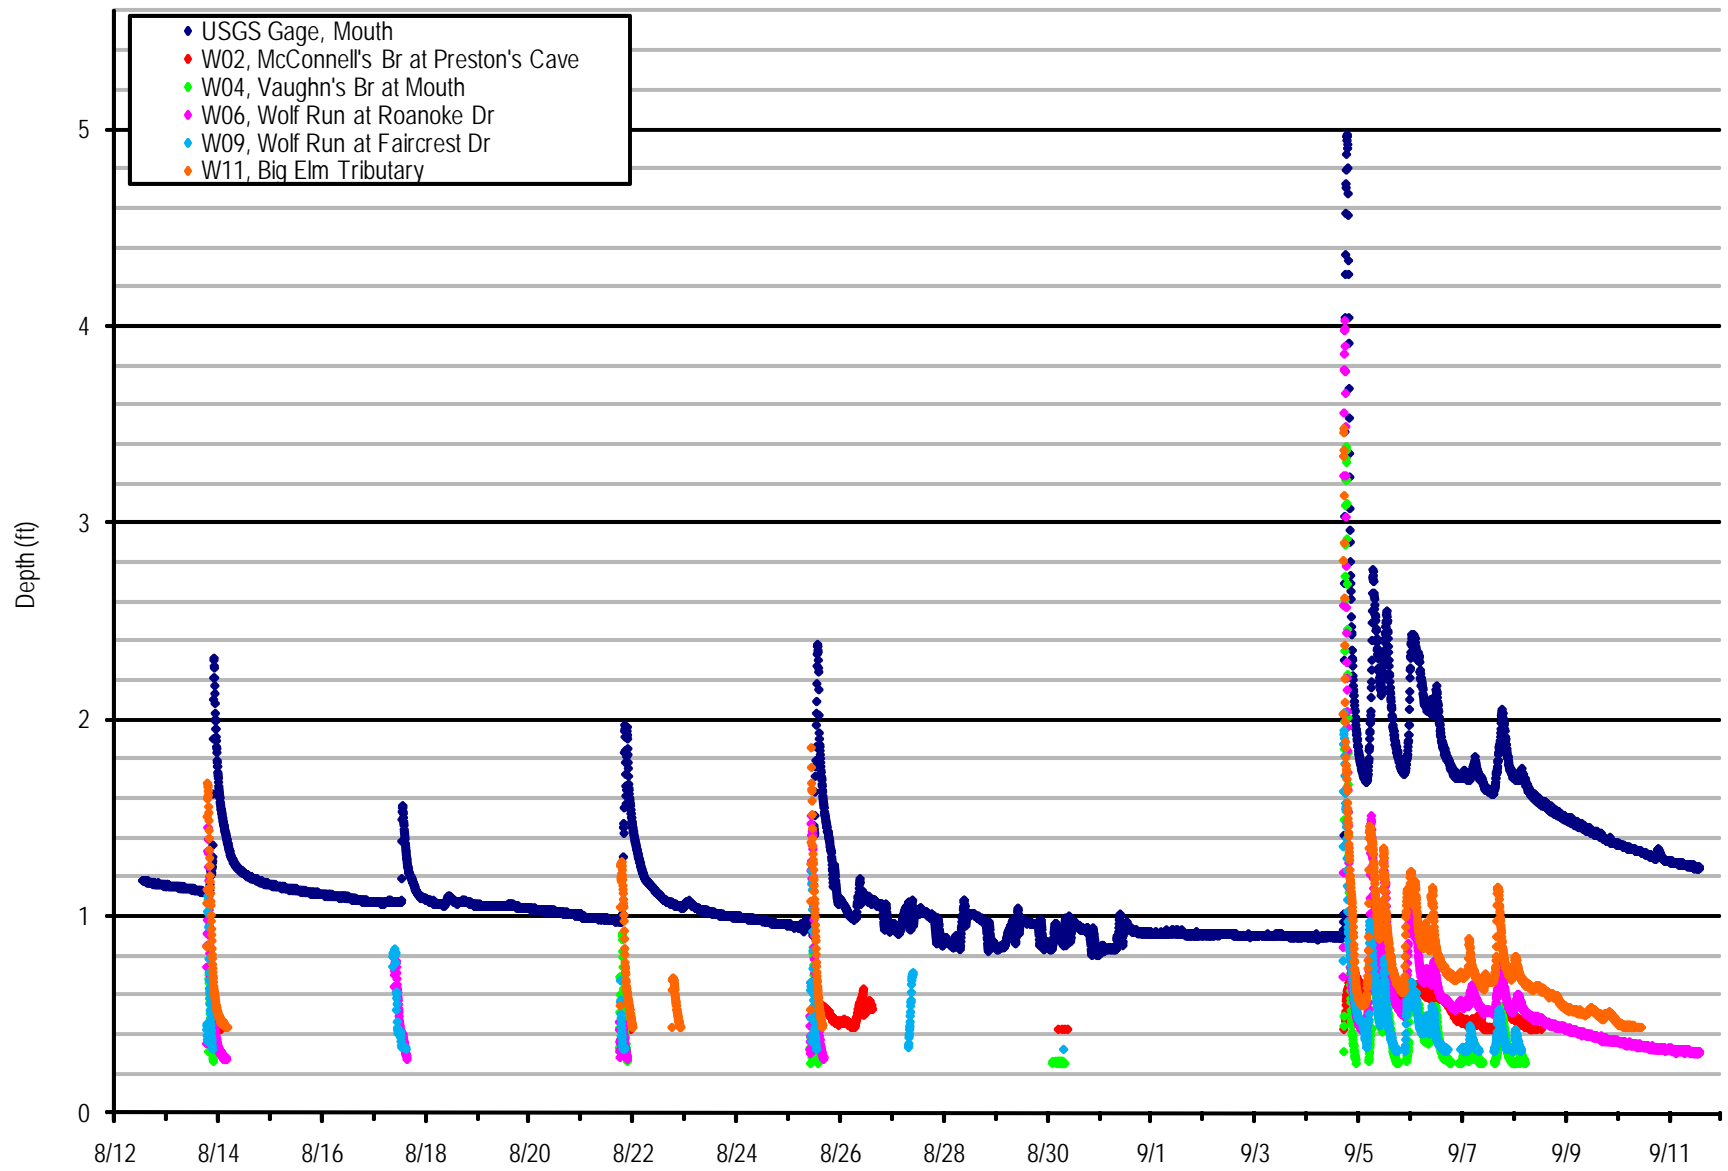
## APPENDIX A – STREAM DEPTH CHARTS

Charts showing the valid logger measurements for the duration of the monitoring period are found in Appendix A.

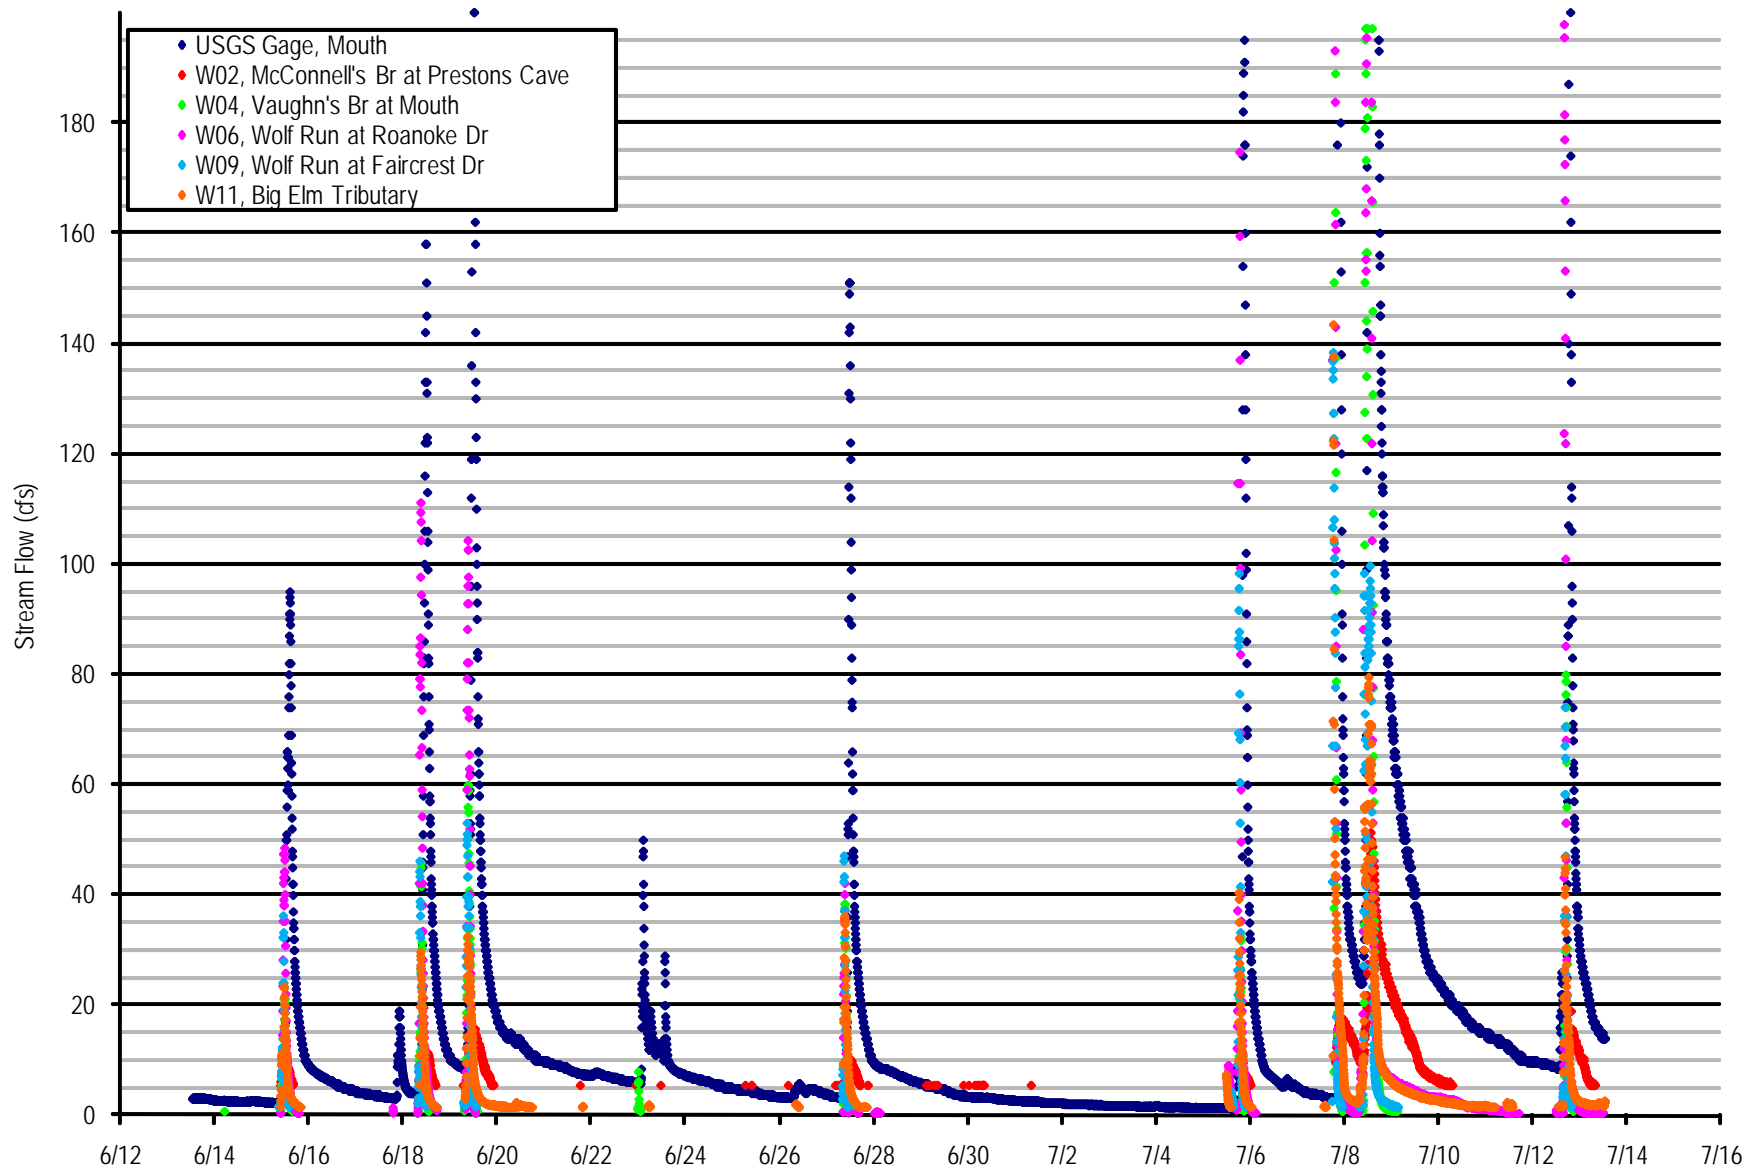
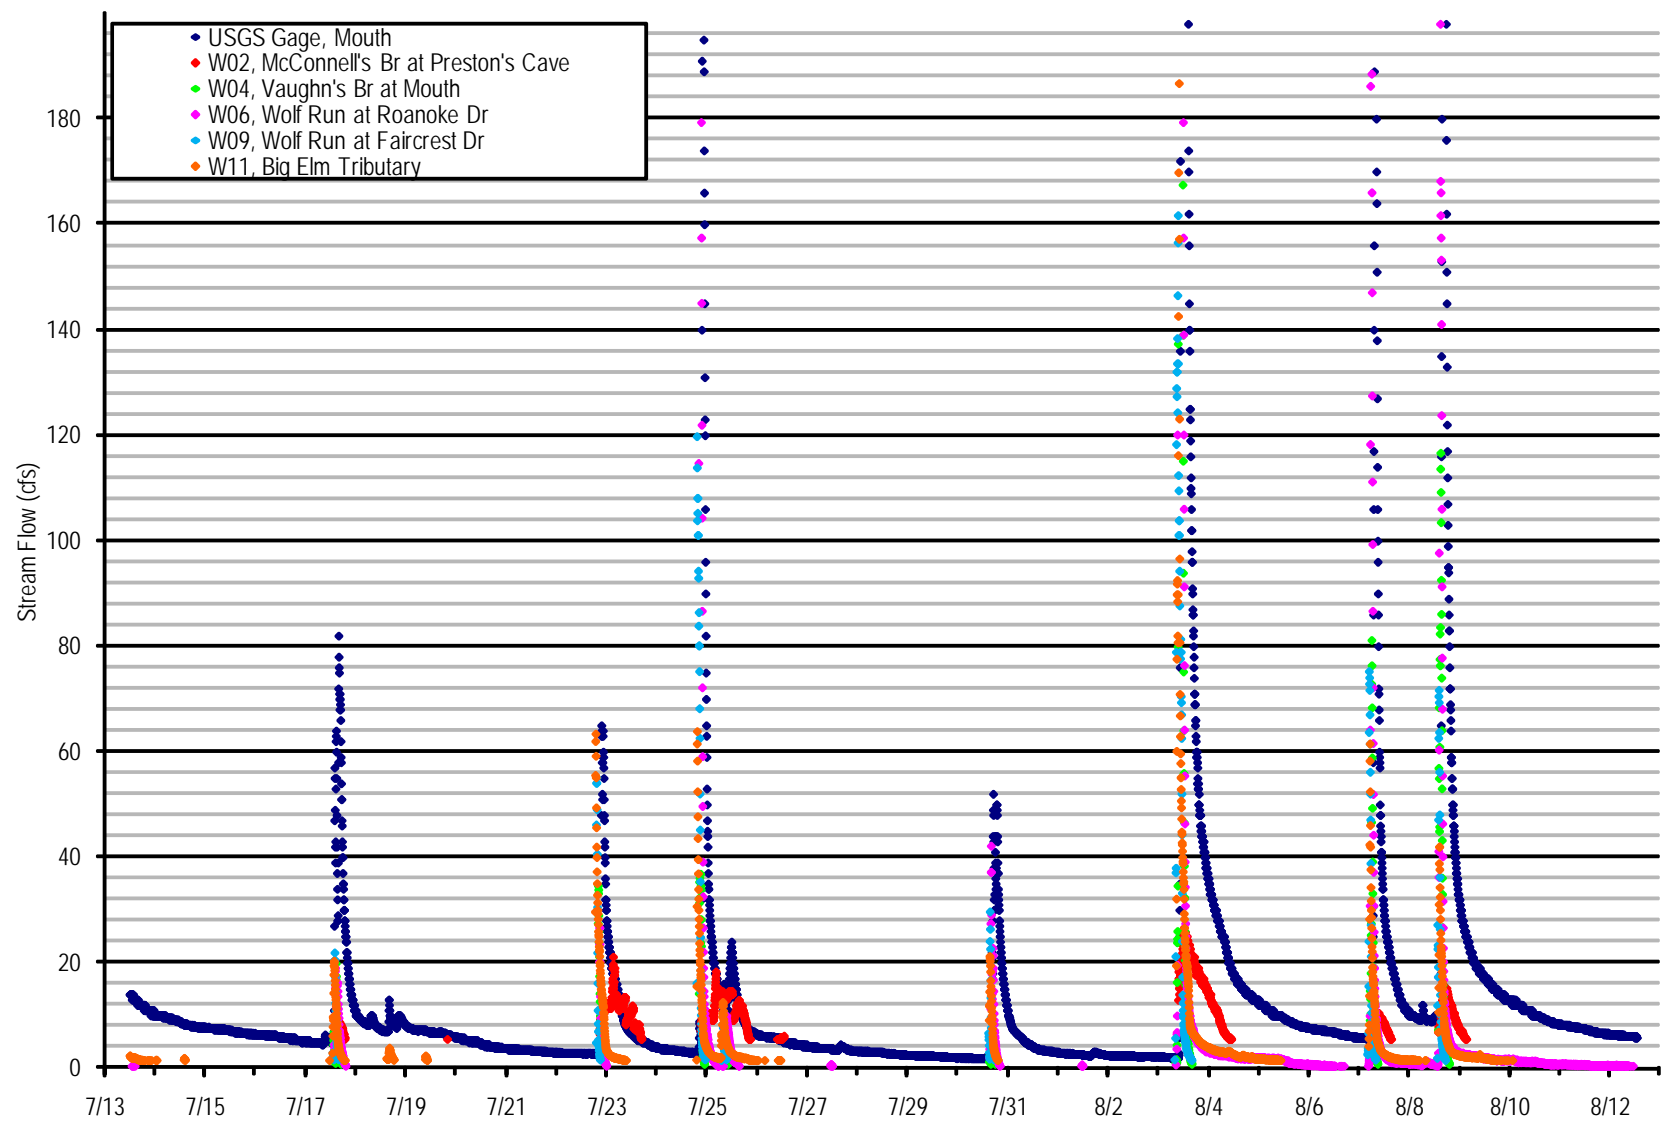
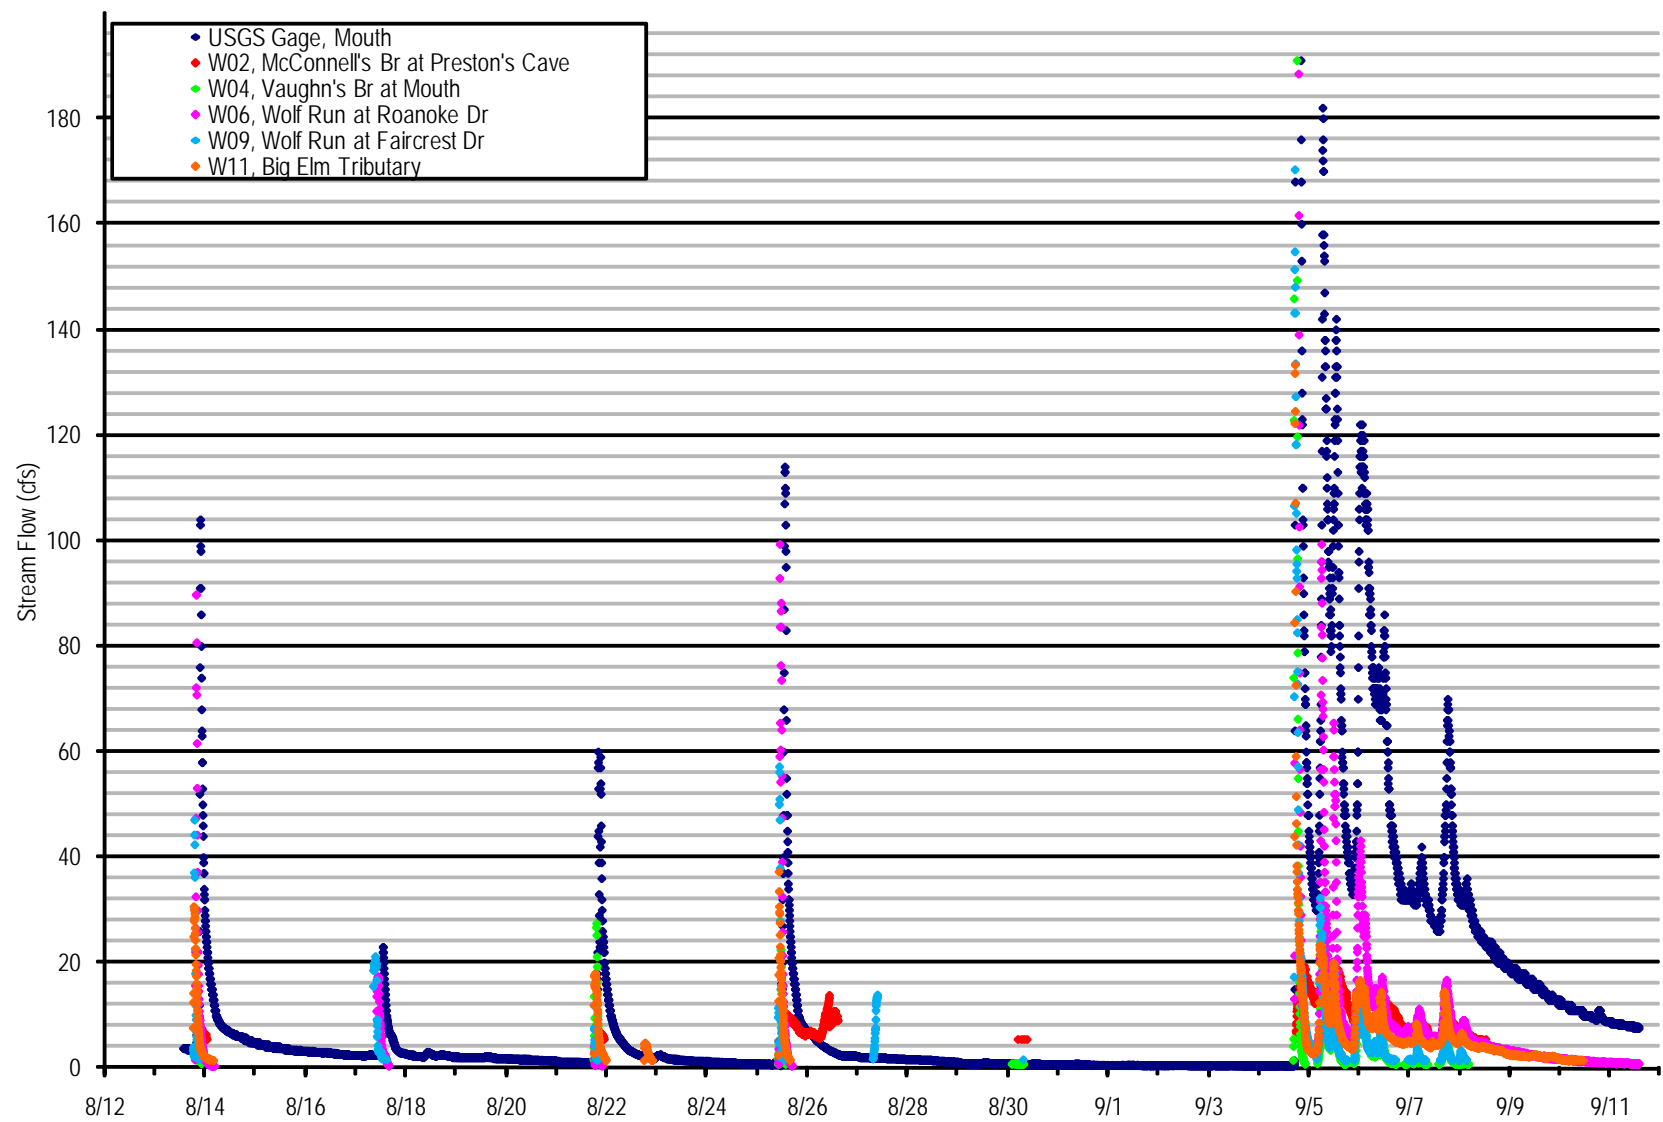
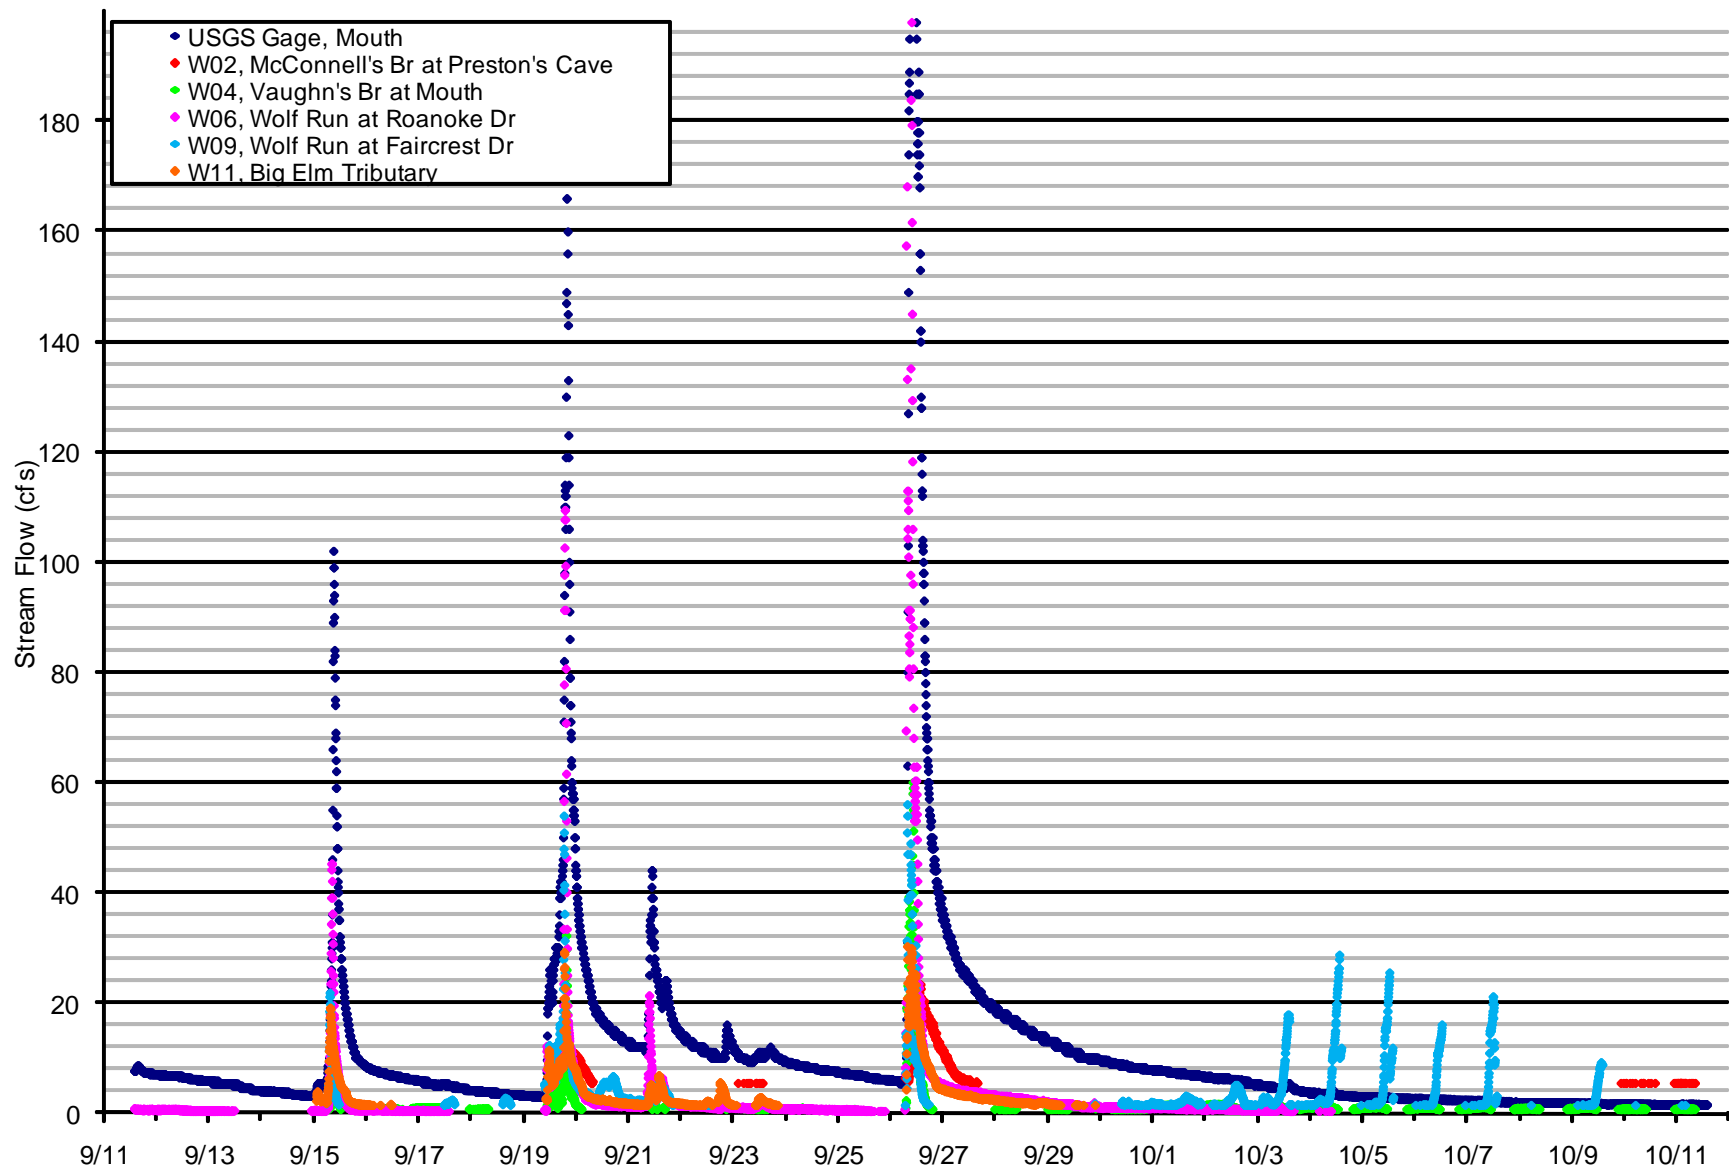
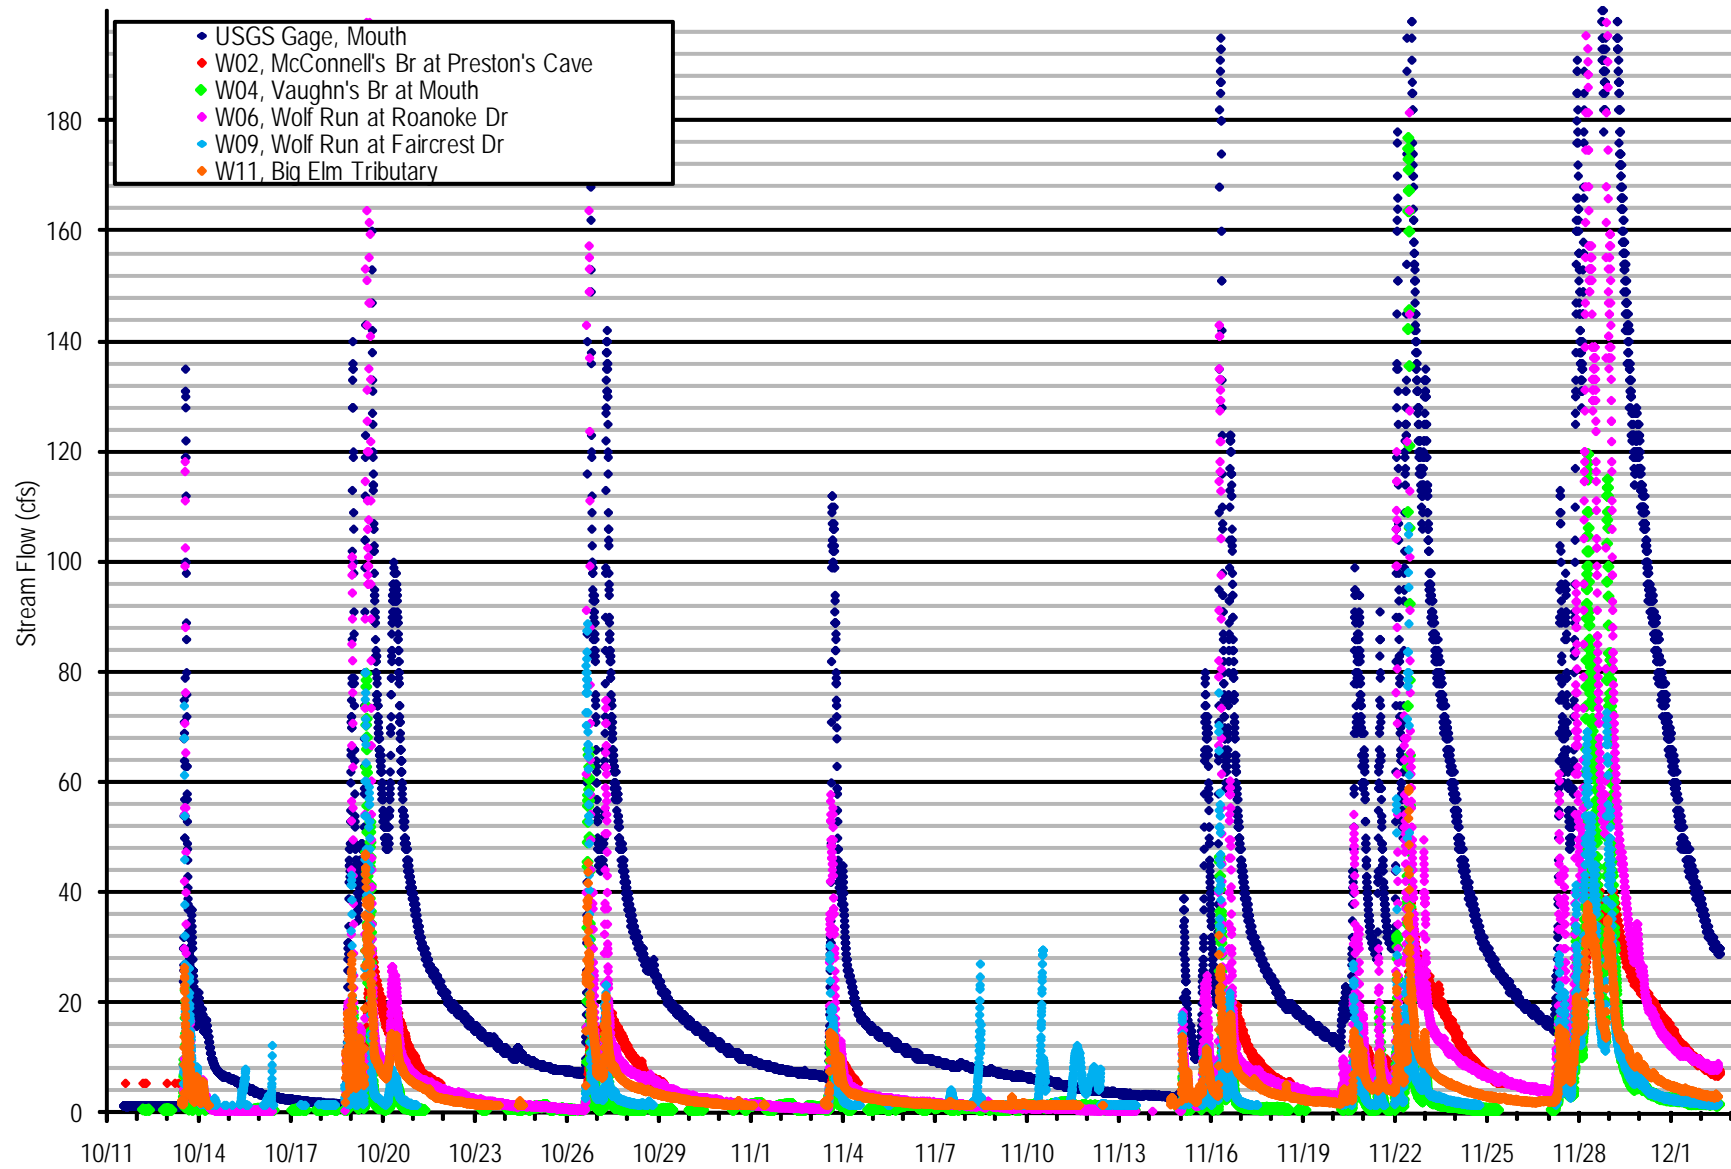
## APPENDIX B – STREAM FLOW CHARTS

The stage-discharge rating curves were utilized to convert the data logger depth measurements into flows for each site. The results for the monitoring period are shown in the charts in Appendix B.
