CHAPTER IV. ANALYSIS

A. Aquatic Community and Habitat

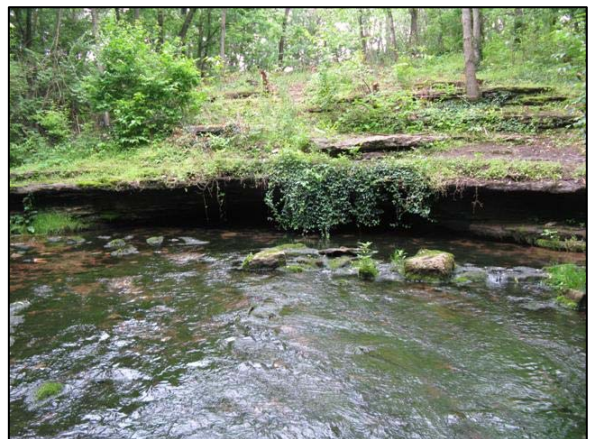
McConnell Branch (W2), which receives most of its flow from Preston's Cave and the upstream McConnell Springs groundwater sources, exhibits modulated hydrology due to the karst drainage. Banks within this reach are relatively stable and not actively eroding. In fact, in-stream deposition and aggradation seems to be more negatively impacting aquatic habitat than erosion. The stream is likely over-widened and thus does not have the capacity to transport the current sediment load. Though this reach is shaded by riparian vegetation, algal growth was observed throughout the reach during 2012 monitoring. Additionally, the riparian vegetation contains non-desirable invasive species and the riparian zone would benefit from invasive species removal/management and establishment of site-specific, native vegetation. Stakeholders indicate that the observed sedimentation at this site may be a result of prior disturbance and fill rather than ongoing sediment transport to the reach. The median particle size in active riffles is medium to coarse gravel. Additional study and design calculations could be used to evaluate what the current sediment load to this stream is (though complicated by the karst drainage) and whether modifications to the channel dimensions and profile could increase sediment transport capacity of the stream in order to alleviate the embedded substrate and sedimentation observed here. This reach has more pattern and more desirable vertical diversity of the streambed, with rather deep pools being measured by the longitudinal profile survey. This reach is an attractive recreational segment accessed by the public on an adjacent trail. Improving the riparian vegetation and sediment transport/aquatic habitat

Preston's Cave, a Unique Geological Feature

would improve this stream as a recreational resource as well as improve stream function/aquatic habitat. Several tributaries enter McConnell Branch within the reach represented by this station. Their condition needs to be further evaluated if this reach is prioritized for remediation activities. There is stakeholder concern about headcutting within a tributary that enters McConnell Branch downstream of the surveyed reach. Unstable tributaries could be contributing high sediment load to McConnell Branch.

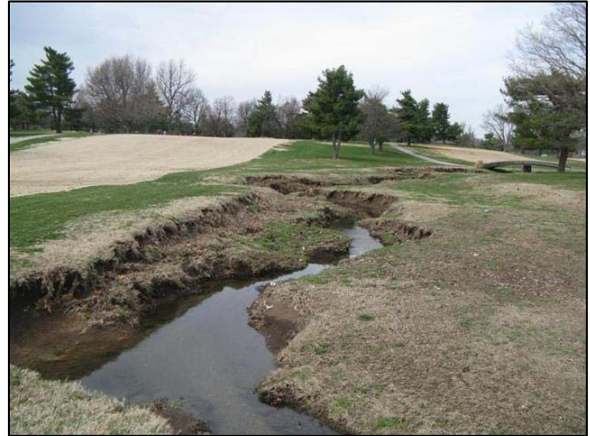
This reach, within Picadome Golf Course, also has a strikingly low habitat assessment score, with very low availability of stable substrate, high indication of substrate embeddedness and in-stream deposition, evidence of eroding banks and little bank protection, and a riparian corridor highly modified by landscape maintenance activities and removal of all streamside, rootwad-producing vegetation. This reach shows numerous areas of severe erosion. Due to its location within LFUCG park property, restoration of stream dimension, pattern, profile, and riparian zone is feasible in this reach if changes to the golf course are acceptable. This is a very public location to showcase a successful stream restoration project and re-connect the public with their water resources. For this reason, this reach has been identified as a priority restoration area.

Erosion on Vaughn's Branch on Picadome Golf Course

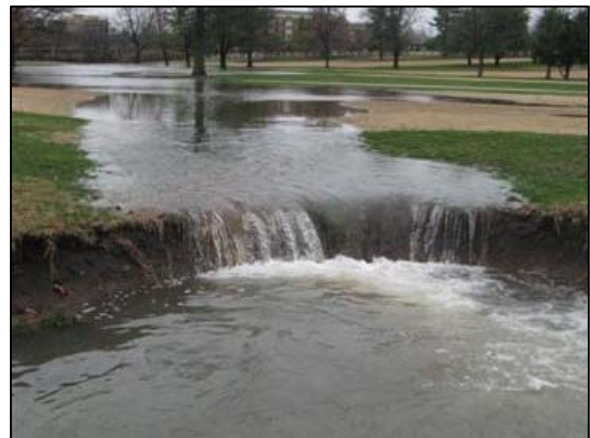
Big Elm tributary contributes flow to Vaughn's Branch within the golf course. However, there is not a stream connecting the two reaches. Under base flow conditions, all of the flow from the Big Elm tributary flows into a large sinkhole. Under flood conditions, the stream flow exceeds the capacity of the sinkhole and floodwater flows across the fairways to Vaughn's Branch. The absence of a channel connection from Big Elm tributary to Vaughn's Branch causes erosion as well as deposition of large debris subsequent to storms. This could be remedied by restoration of the channel, though it will impact play at the golf course and require careful planning.

Stream Flow and Erosion across Fairways from Big Elm Tributary to Vaughn's Branch

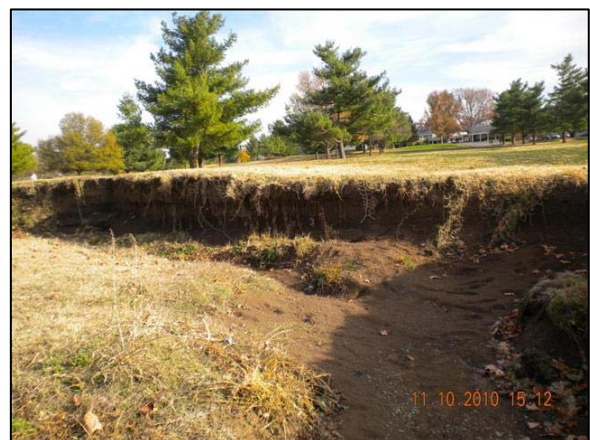
Severe Erosion on Big Elm Tributary near Picadome Sinkhole

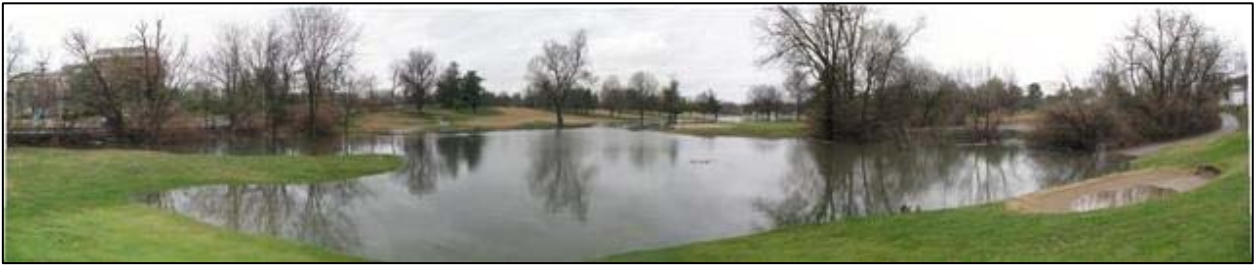
In addition to quantifying the degree of flashiness in the watershed and the range of flows measured on the tributaries to Wolf Run, the study helped to clarify the relationship between surface and karst groundwater flows, particularly under storm conditions at the confluence of the Big Elm Tributary and Vaughn's Branch. The study found that as the karst conduit's flow capacity is maximized, through upstream inputs such as Wolf Run at Southbend Drive or through the maximized capacity at the spring outlets (McConnel Springs), water begins to back up at the Picadome sinkhole until flood levels are sufficient to allow for the bypass across to Vaughn's Branch. Under these conditions, almost the entire flow from the Big Elm Tributary enters Vaughn's Branch. Once the groundwater system has additional capacity to accept additional flow input, floodwaters begin to decline at the Picadome sinkhole. These multiple inputs into the karst system cause higher flow levels at McConnell Branch to be sustained for longer periods of time while also suppressing the peak flows and lengthening both the rising and falling limbs of the hydrographs in the headwater areas of Wolf Run and the Big Elm Tributary.

Panorama of Flood Waters at Confluence of Big Elm Tributary and Vaughn's Branch

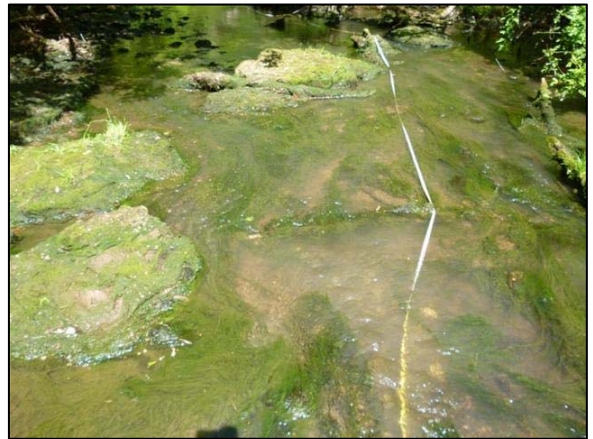
Abundant algal growth was observed at multiple areas across the Wolf Run Watershed as identified in Exhibit 28, page IV-16. This algal growth is caused by excessive nutrient loading and lack of stream shading and causes low dissolved oxygen levels and high pH. Aquatic plants and algae, which produce oxygen during the day through photosynthesis, consume dissolved oxygen after sunset, when no photosynthesis occurs. If a large volume of aquatic plant material is present in the stream, the plants may use so much dissolved oxygen that conditions toxic to aquatic life are produced at night. Additionally, abundant decaying plant matter leads to excessive oxygen use during bacterial decomposition. Fish require at least 5 to 6 mg/L of dissolved oxygen for normal activity. Levels below 4 mg/L are stressful, and levels below 2 mg/L are lethal. No fish kills were known to occur during the monitoring period.

Significant Algal Growth on McConnell Branch

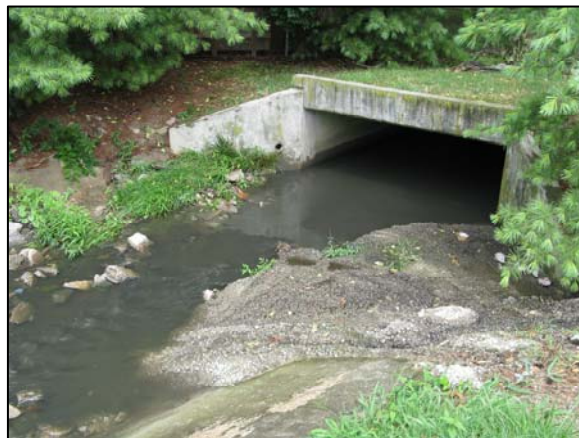
Total suspended solids were, as expected, higher in wet weather events than during dry and intermediate events. Sites W01, W03, W04, W09, and W10 each had suspended solid levels exceeding 80 mg/L with a high of 200 mg/L measured at W10 on October 13. All of these elevated events occurred during wet events. During wet weather events with high concentrations of suspended sediment, the color of the water is typically black or gray rather than brown like the soil color. Although erosion is a contributor to the suspended sediment load, the color of the turbidity indicates that stormwater runoff is a greater contributor to suspended sediments in Wolf Run.

*Grey Colored Stormwater on Vaughn's Branch
Upstream of Picadome Golf Course*

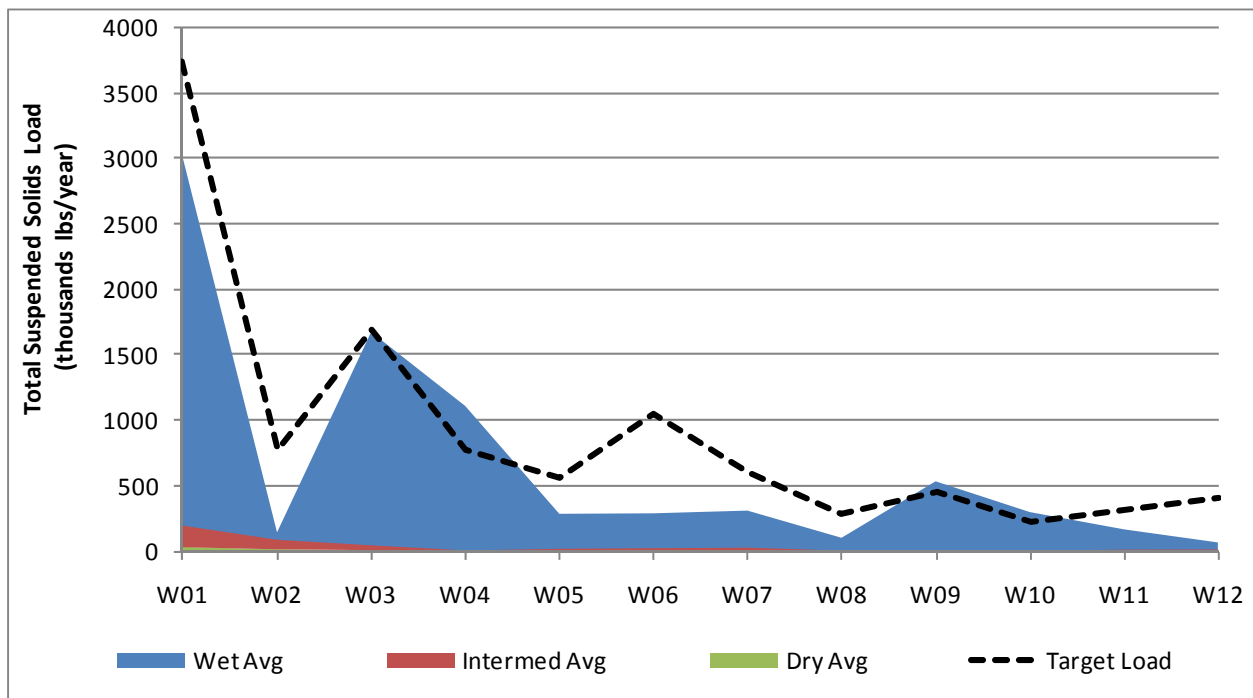
FIGURE 9 – ANNUAL TOTAL SUSPENDED SOLIDS LOADING CONTRIBUTIONS BY EVENT TYPE

*Target load based on 80 mg/L non-regulatory reference point.
