Hydrogeomorphic Assessment Report

Wolf Run Watershed Fayette County, Kentucky

September 4, 2012

Prepared by
Third Rock Consultants, LLC
2526 Regency Road, Suite 180
Lexington, KY 40503
859.977.2000

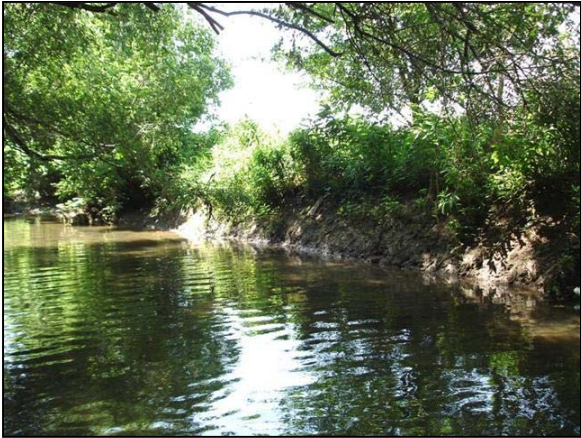
*W1, 2011, Left Bank Erosion Area within
Surveyed Reach*

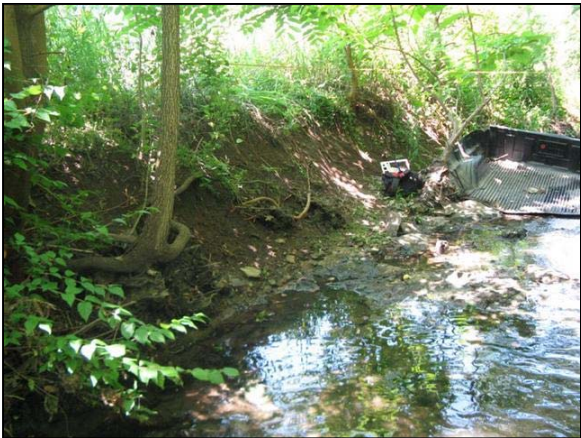
W4, 2012, Left Bank Erosion within Surveyed Reach; Exposed Tree Roots

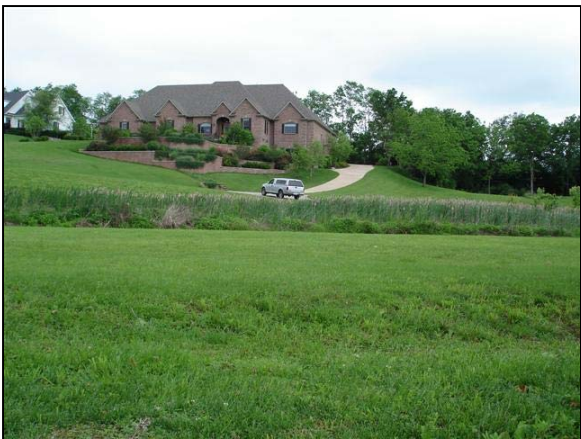
W5A, 2011, Wetland And Lawn Areas Adjacent To Surveyed Reach

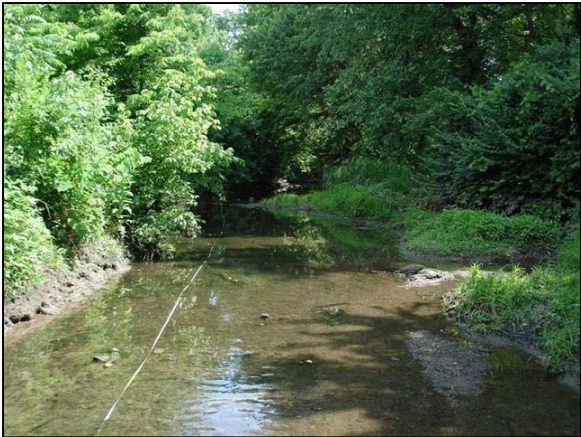
W6, 2011, Embedded Substrate; Little Vertical Streambed Diversity

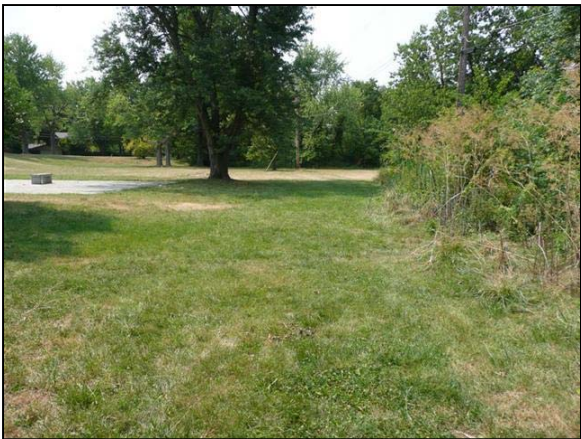
W6, 2012, Riparian Area Could be Expanded within Wolf Run Park

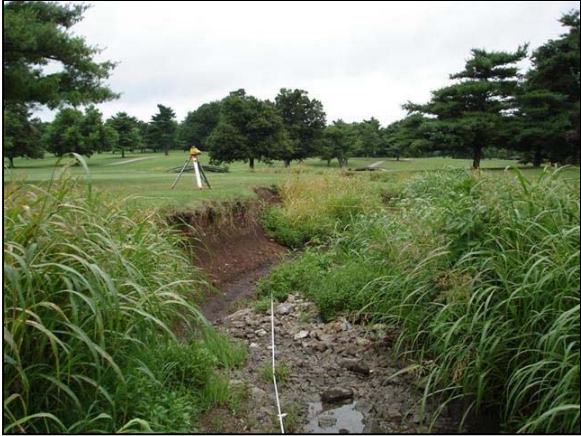
W8, 2011, Bank Erosion and No Riparian Buffer

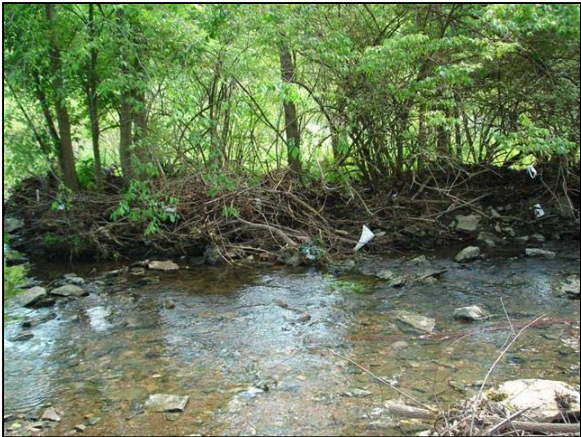
*W9, 2011, Poor Quality Riparian Zone Offering Little
Bank Protection*

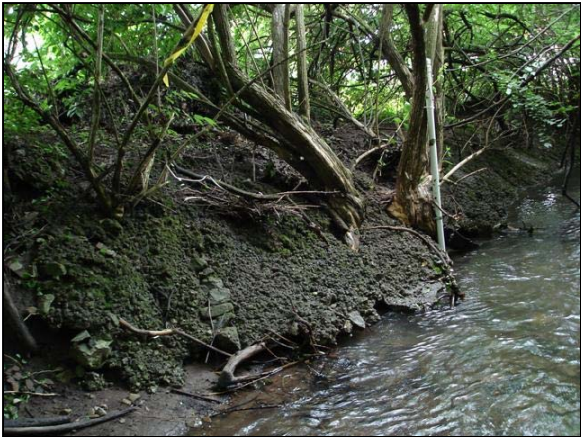
W11, 2011, Concrete Armoring Within Surveyed Reach

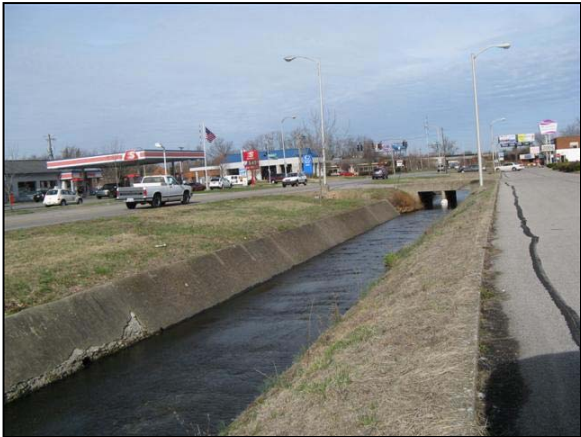
Wolf Run, Concrete Channel Contained Within Southland Drive; Not Characterized By Study

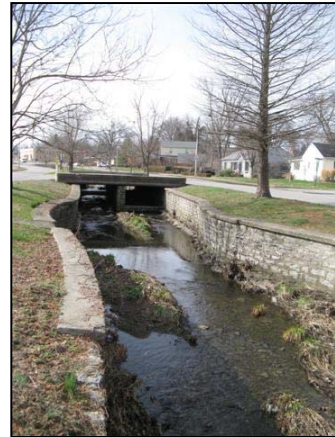
Wolf Run, Concrete And Rock Channel Contained Within Street At Rosemont Garden; Not Characterized By Study
